Manhole Inspection Summary

Manhole # S15II1023MH

Location Address: **2431 COLD SPRING LN**

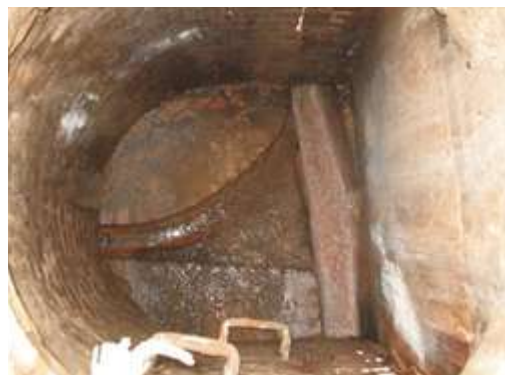
Top View

Corroded and missing steps. Bench debris.

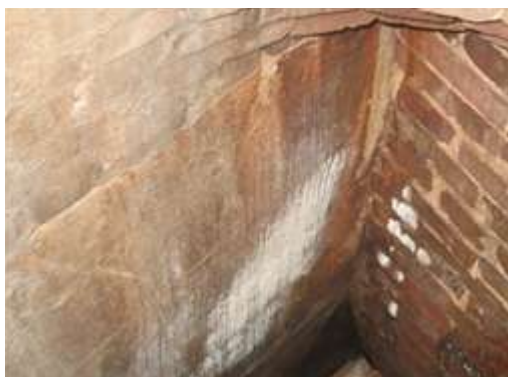
Defect

Corbel and Barrel infiltration.

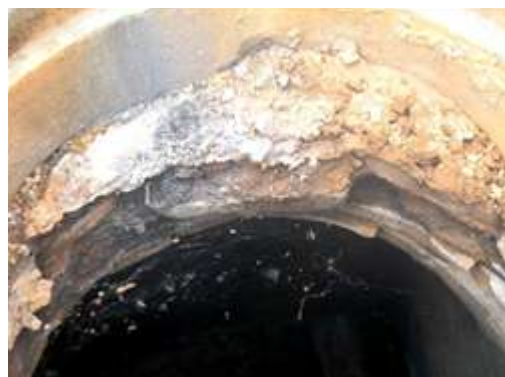
Defect

Frame leaks. Frame offset. Adjustment deterioration and infiltration.

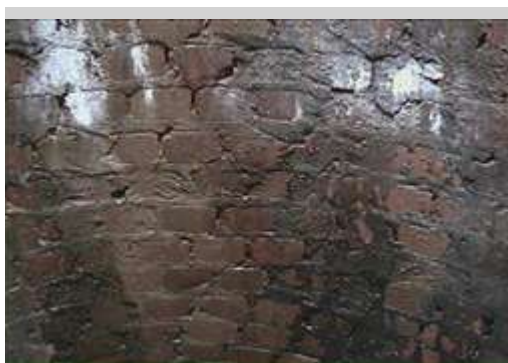
Defect

Corbel deterioration and infiltration

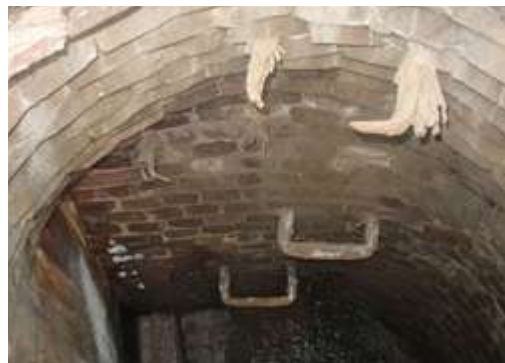
Defect

Corroded and missing steps. Corbel and Barrel infiltration.

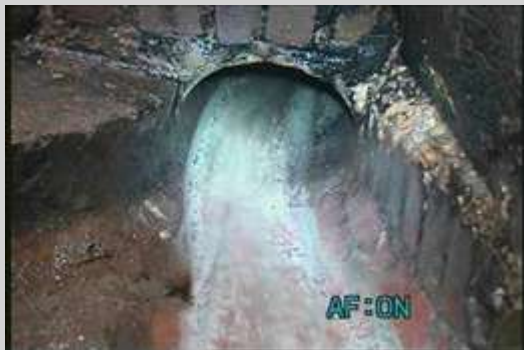
8 in. Circular Gravity Sewer Pipe Out @ 12 O'Clock

Deposits: ☐ None ☐ Mud ☐ Sludge ☐ Debris ☒ **Grease**

Infiltration: **Evidence** Pipe Seal Cond: **Unknown**

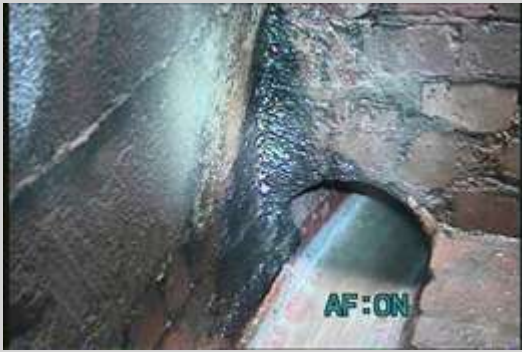
Pipe In @ 6 O'Clock

Barrel infiltration.

Deposits: ☐ None ☐ Mud ☐ Sludge ☐ Debris ☒ Grease

Infiltration: **Evidence** Pipe Seal Cond: **Unknown**
